Figure 1. PL image of as-grown defects in CZ Si

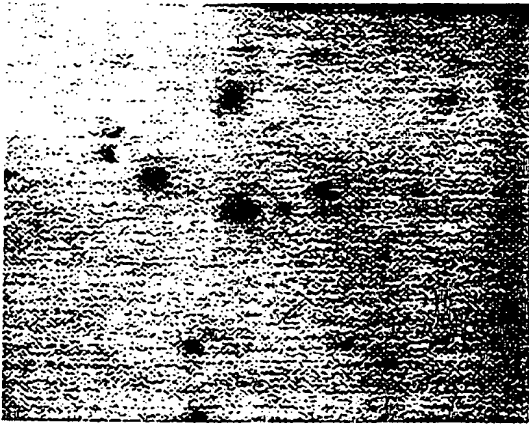
Figure 2. PL image of as-grown defects in CZ Si after Fe contamination  $1 \times 10^{11}$  atoms/cm<sup>2</sup>

Scan area 1mm x 1mm

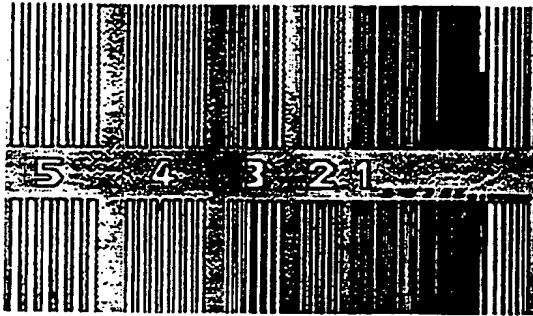
**Figure 7. Micrograph of LOCOS test structure**

Scan area 120 x 60  $\mu\text{m}$
